WHAT IS SALT DAMP?

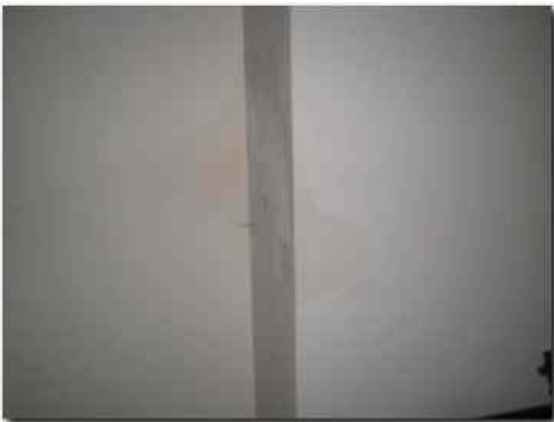
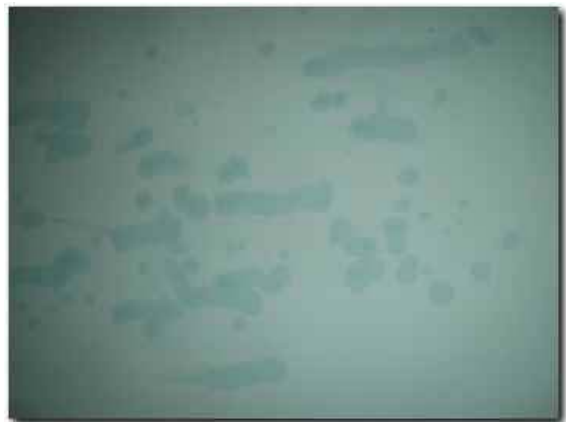
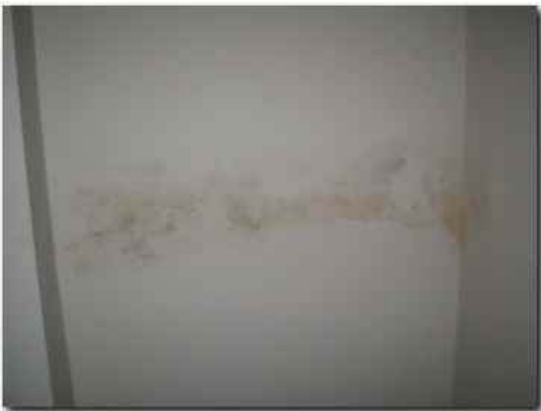
Where plaster after a damp proof course has not been taken high enough, a salt band may occur as illustrated below.

Salt damp is closely associated with rising damp. When a new damp proof course is installed, the lower wall areas are re-plaster with salt resistant plaster.
